# **ASBESTOS CONTAINING MATERIALS SURVEY**

**Hope Lighthouse Ministries (HLM) Buildings  
444 Irwin Avenue  
Muskegon, Michigan**

Horizon Environmental  
4771 – 50<sup>th</sup> Street, S.E., Suite One  
Grand Rapids, Michigan 49512

January, 2012

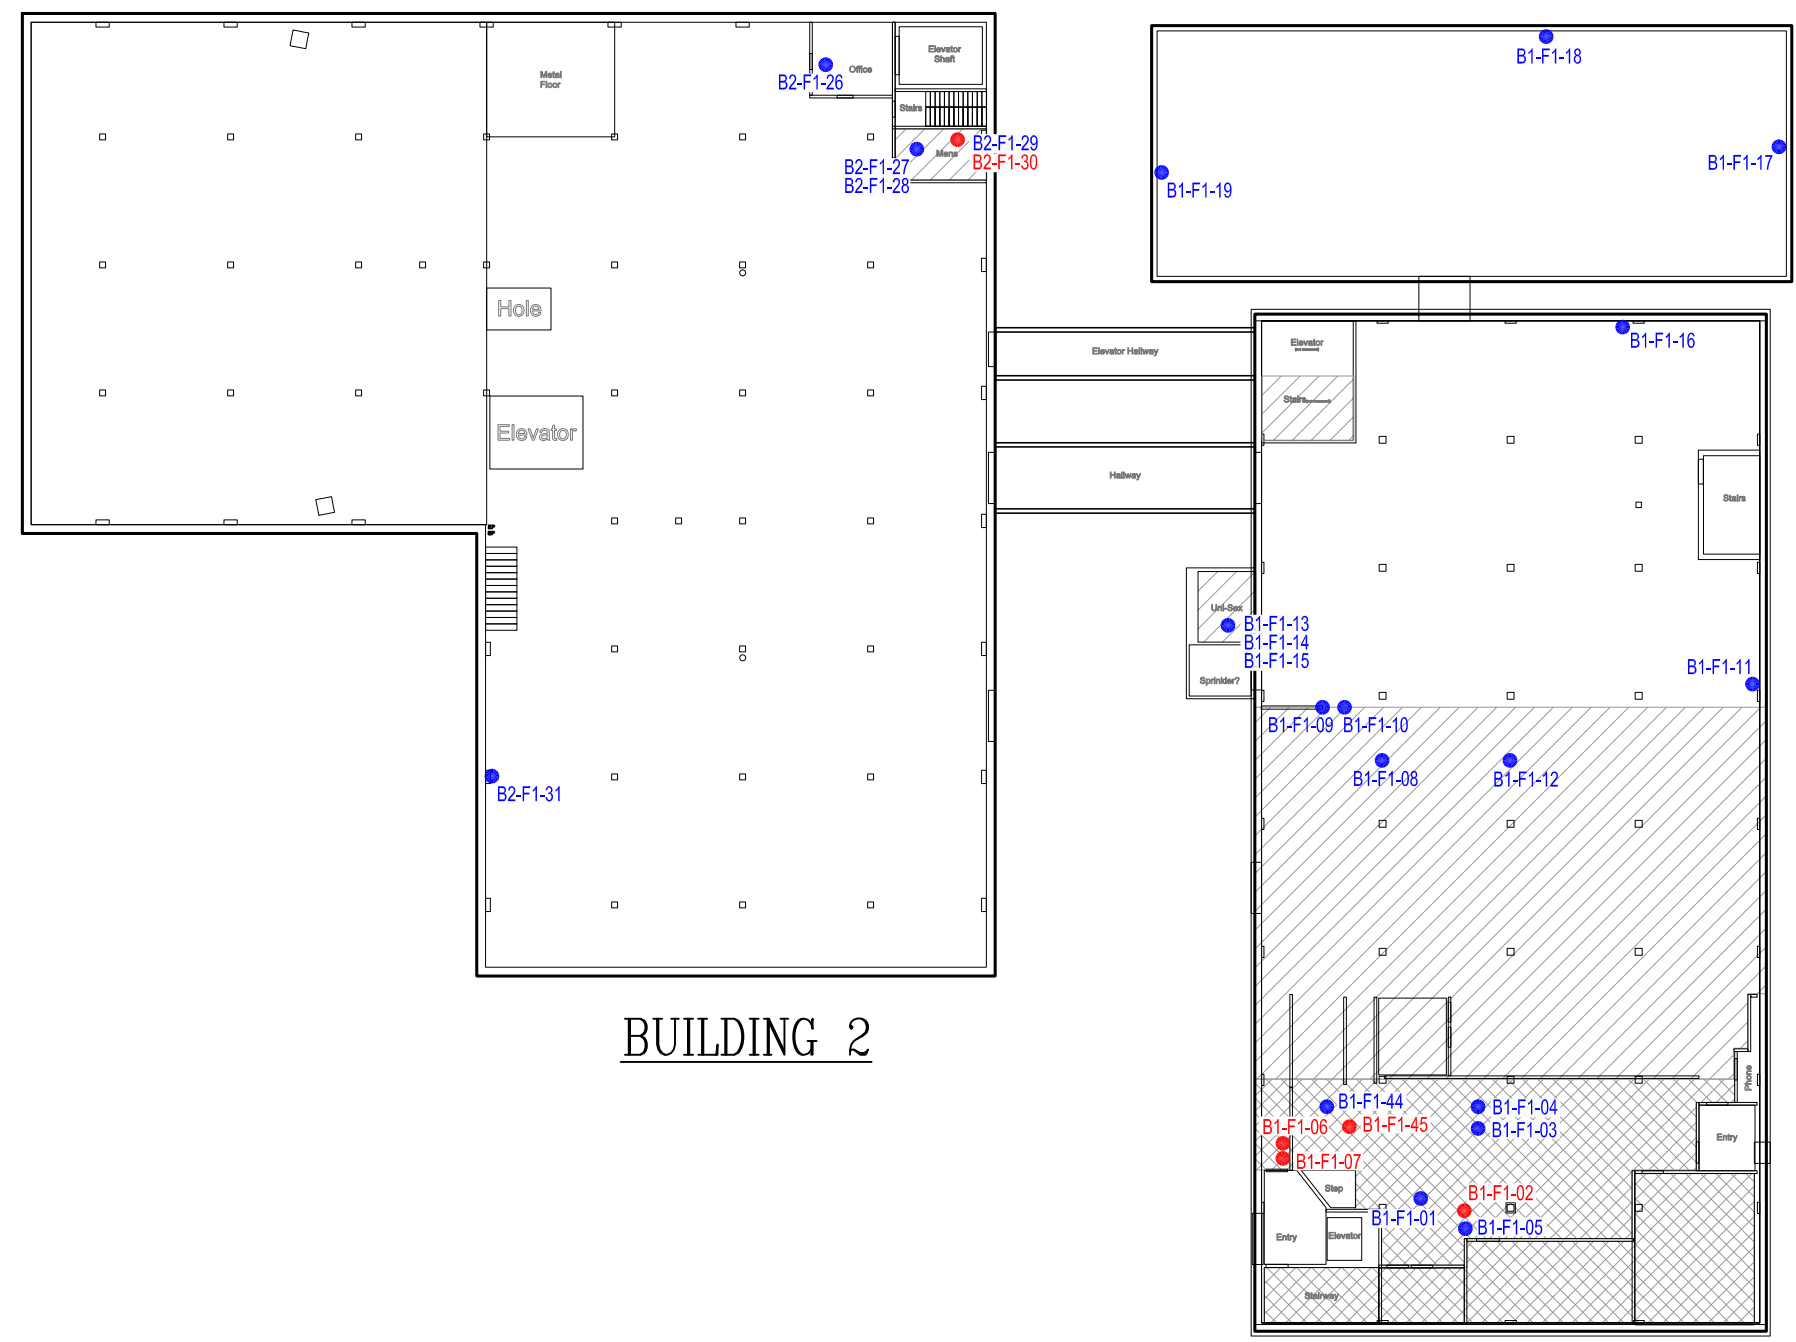
ASBESTOS SAMPLE LOCATIONS  
FIRST FLOOR

As shown on Figure 2, asbestos containing floor tile and floor tile mastic were discovered in the southern portion of the first floor of Building 1. In this portion of the building, gray 12 by 12-inch floor tile overlies a second layer of what appeared to be brown 12 by 12-inch floor tile. Both the top and bottom (i.e., gray and brown) layers of floor tile were found to contain between 2% to 4% asbestos. The black mastic associated with the floor tiles was also found to contain 2% to 4% asbestos. Both layers of floor tile are secured to their respective substrate with black mastic. A summary of the floor tile and mastic samples that contain asbestos is as follows:

<b>Sample No.</b>	<b>Building Material</b>	<b>Sample Location</b>	<b>Percent Asbestos</b>
FE-ACM-B1-F1-02		North of office 1	
Layer 1	12"x12" gray floor tile		2%
Layer 2	Black mastic		2%

<b>Sample No.</b>	<b>Building Material</b>	<b>Sample Location</b>	<b>Percent Asbestos</b>
FE-ACM-B1-F1-06 Layer 2	Black mastic	North of front entry	2%
FE-ACM-B1-F1-07 Layer 1 Layer 2	12"x12" brown floor tile Black mastic	North of front entry	3% 4%
FE-ACM-B1-F1-45 Layer 1 Layer 2	12"x12" brown floor tile Black mastic	North of receptionist raised platform	4% 2%

Floor tile and mastic sampled from other areas in the HLM buildings did not contain asbestos. Assuming that the asbestos containing floor tile and mastic is limited to the first floor of Building 1, there are approximately 8,000 square feet of ACM floor tile and mastic, of which approximately 3,200 square feet is double-layered floor tile.

On the first floor of Building 2, a small section of piping was found to be insulated with suspect ACM. The pipe is a 5 inch water line located above the drop-ceiling in the northeast corner men's bathroom, with approximately 8 to 10 lineal feet of insulation. The insulating material is a combination of fabric pipe wrap and mudded fittings. A depiction of the sample location is provided as Figure 2. The sample of pipe wrap did not contain asbestos; however, the mudded fitting sample that was collected contained 8% asbestos.

<b>Sample No.</b>	<b>Building Material</b>	<b>Sample Location</b>	<b>Percent Asbestos</b>
FE-ACM-B2-F1-30	Pipe insulation	Men's restroom	8%

There are approximately 4 asbestos-containing mudded fittings located above the bathroom on the first floor of Building 2.

The floor tile and mastic that contains asbestos does not need to be removed from the building if it is appropriately maintained. If more than 160 square feet of asbestos-containing floor tile and mastic are to be removed, and the removal is done such that the ACM will be reduced to powder (i.e., become “friable”) during the removal process, a 10-day notification to the Michigan Department of Environmental Quality (MDEQ) and Michigan Department of Licensing and Regulatory Affairs (LARA) is required pursuant to NESHAP, 40 CFR Part 61, Subpart M. If floor tile and mastic are removed in a manner that does not involve grinding, cutting, abrading, or pulverizing and there is no potential for the ACM to become friable during removal, no notification is required.

Asbestos containing insulating mud was found to be present on approximately 4 individual fittings on a single 5-inch pipe above the men’s bathroom on the first floor of Building 2. No other mudded pipe fittings were identified in either Building 1 or Building 2 during the survey. Pipe insulating mud is regulated as a friable asbestos-containing material. This material does not need to be removed from the building if it is properly maintained. If this material is to be removed from the building, it is exempt from NESHAP notification requirements because less than 10 lineal feet of material are present in the building (40 CFR, Part 61.145, Paragraph A).

Any removal activities of asbestos-containing floor tile, mastic, or pipe insulating mud should be performed by qualified personnel, regardless of notification requirements.
